SITE ASSESSMENT REPORT VOLUME I

111th FIGHTER GROUP
WILLOW GROVE AIR RESERVE STATION
PENNSYLVANIA AIR NATIONAL GUARD
WILLOW GROVE, PENNSYLVANIA

## FINAL SITE ASSESSMENT REPORT MOTOR POOL AREA, BUILDING NO. 352

## 111th FIGHTER GROUP WILLOW GROVE AIR RESERVE STATION PENNSYLVANIA AIR NATIONAL GUARD WILLOW GROVE, PENNSYLVANIA

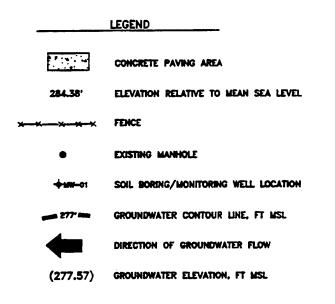
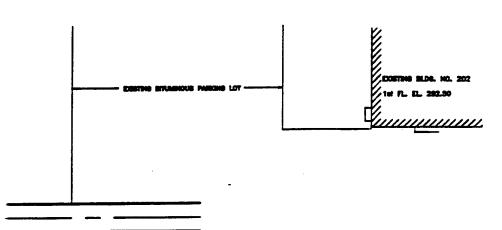
FIGURE 3.6 POTENTIOMETRIC SURFACE MAP 11/6/93 MOTOR POOL AREA WILLOW GROVE AIR RESERVE STATION

During the SA, it became apparent that bedrock beneath the MPA occurred at a somewhat shallower depth than in areas where the RI was conducted, and as a result, the shallow groundwater table occurred under confined conditions within the bedrock (Stockton Formation) beneath the MPA.

Borings installed to refusal (about 5 ft to about 18 ft BGS) during the initial SA did not encounter saturated conditions. As a result, air rotary drilling was used to advance four borings into the bedrock where water was encountered at approximately 21 ft BGS. Water levels obtained from monitoring wells installed in three of these boreholes (MW-01 through MW-03) on November 6, 1993, are presented in Table 2.2. A potentiometric surface map (Figure 3.6) was constructed using this information, and indicates groundwater flow in the Stockton Formation beneath the MPA is toward the north, from MW-01 toward MW-02 and MW-03. The hydraulic gradient between monitoring wells MW-01 and MW-03 was 0.017 ft/ft on November 6, 1993. During the SA in September 1994, groundwater was encountered in the unconsolidated deposits in one borehole (SB-28) at a depth of 17 ft BGS. Because groundwater elevations observed in MW-01 through MW-03 were generally consistent with data obtained in 1993, a separate potentiometric surface map was not prepared. Based on the measured groundwater elevations, a gradient of 0.017 ft/ft, an assumed effective porosity of 10%, and a hydraulic conductivity of 2.12 × 10⁴cm/sec (D&M RI), a calculation of groundwater velocity in the bedrock can be made using a modified form of Darcy's equation:

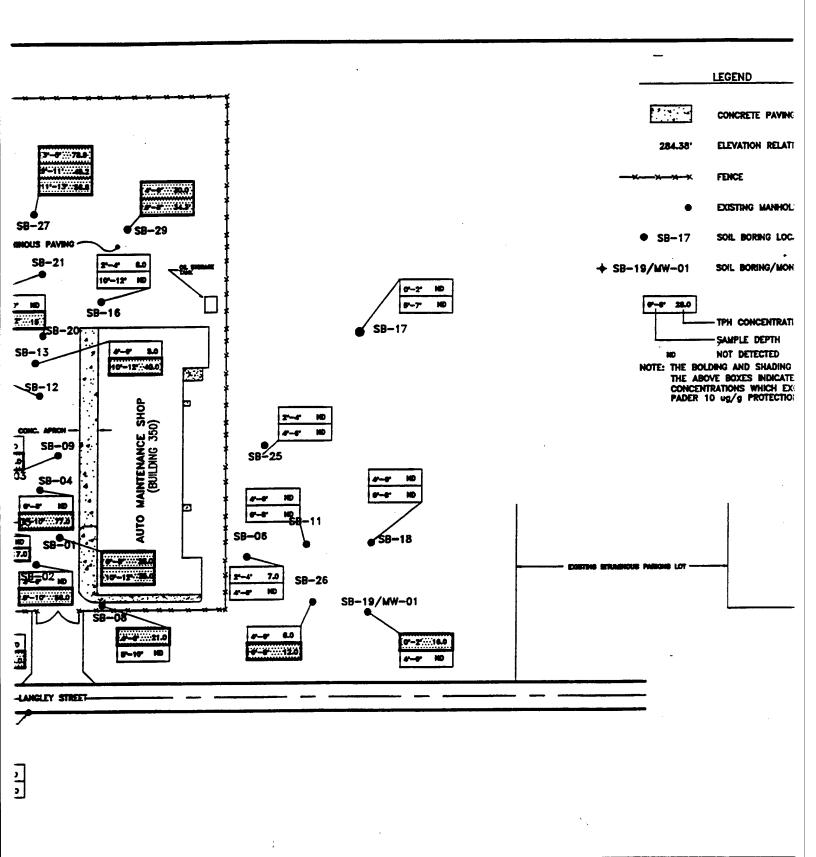
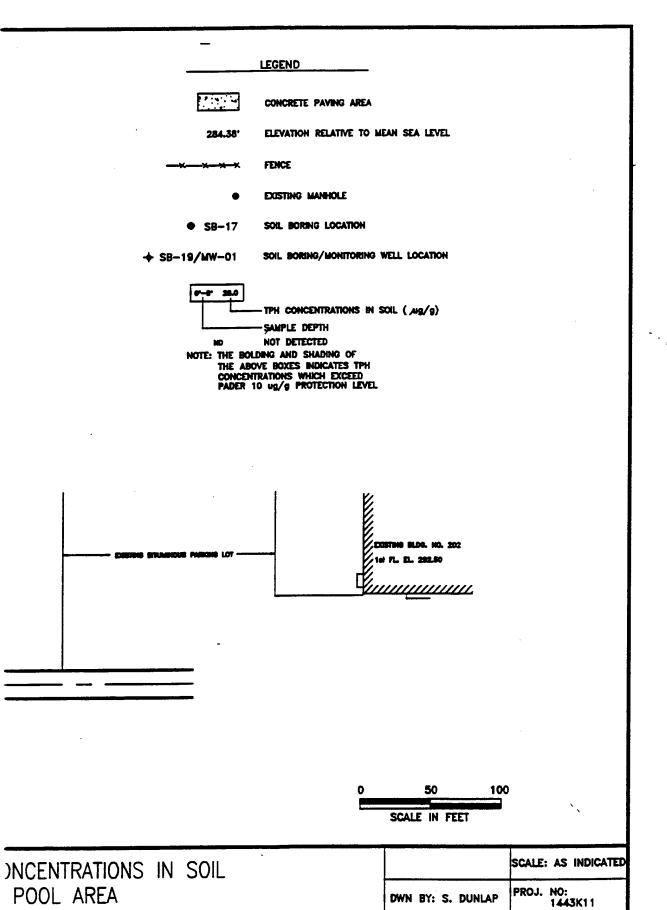
FIGURE 3.7 TPH CONCENTRATIONS IN SOIL

- impacts to the unconsolidated soils by TPH exist both within the MPA and in areas outside the MPA,
- concentrations of TPH in the soil ranged from non detect (less than 5  $\mu$ g/g) to 79  $\mu$ g/g,
- soil samples from four of the five borings submitted for laboratory BTEX analyses contained BTEX constituents (one sample exceeded the PADER Protection Levels), and
- groundwater is impacted by BTEX and TPH constituents at locations immediately downgradient of the former tank excavation.

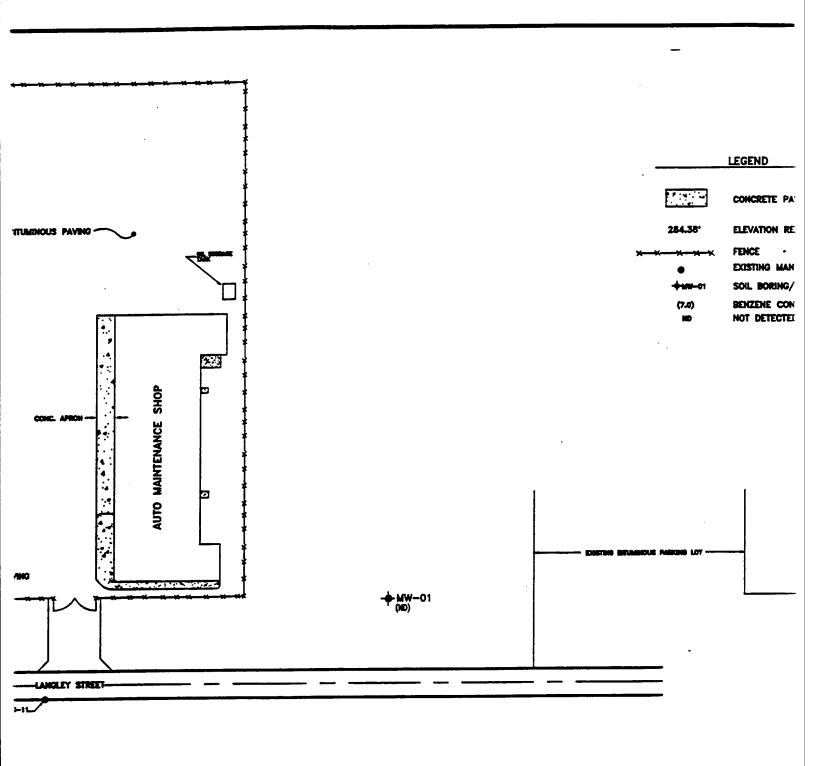
FIGURE 3.8 BENZENE CONCENTRATIONS IN GROUNDWATEF MOTOR POOL AREA, NOVEMBER 6, 1993 WILLOW GROVE AIR RESERVE STATION

Both groundwater samples which exceed the PADER MCLs were collected from monitoring wells located downgradient of the former tank system. Monitoring well MW-03 is located slightly down and sidegradient from the former tank system location. Monitoring well MW-02 is located directly downgradient of the former tank system. This location difference is the probable cause of the different benzene concentrations in the groundwater. The upgradient monitoring well did not contain detectable concentrations of BTEX or TPH constituents.

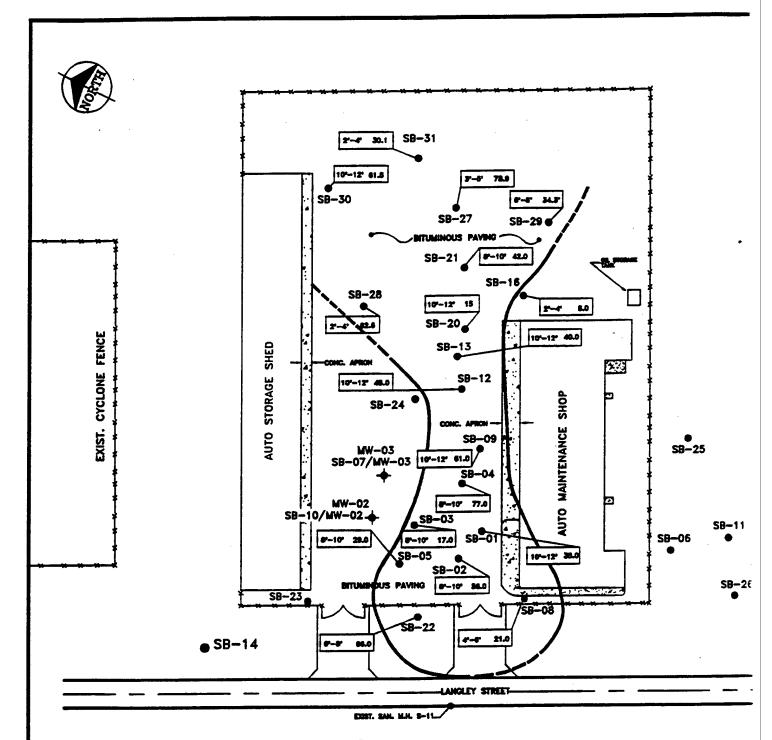
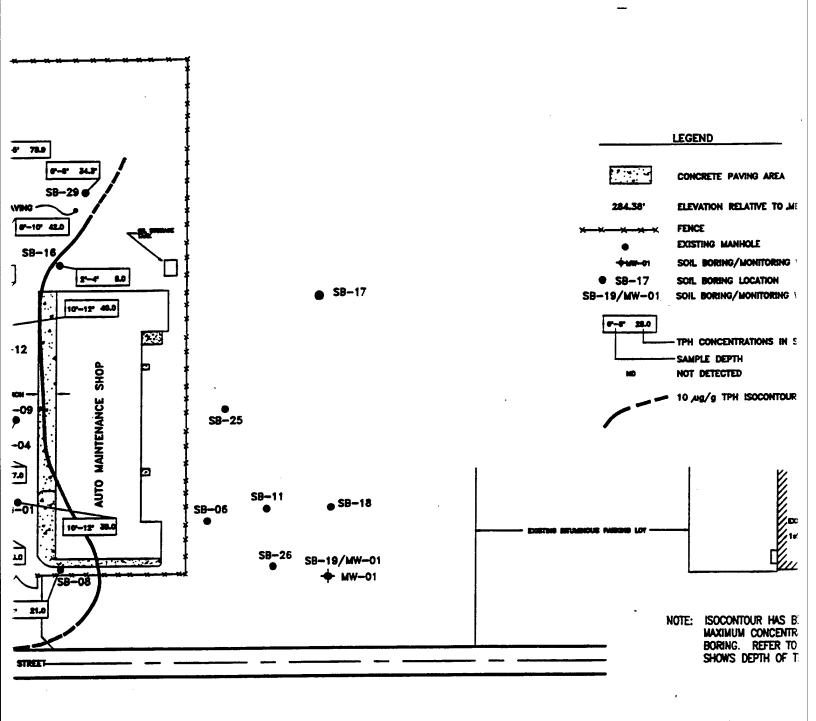
FIGURE 4.2 10 µg/g TPH ISOCONCENTRATION CONTOUR MOTOR POOL AREA WILLOW GROVE AIR RESERVE STATION

The area of soil impacted by TPH has been defined to the northwest, west, southwest, and east of the former UST. However, the boundary of TPH impacted soil toward the northeast has not been defined. The TPH impacted soils associated with the former USTs occur within the unconsolidated deposits. Generally the depth of impacted soils is 8 to 12 ft BGS in the vicinity of the former UST locations. This is consistent with a subsurface release mechanism, i.e., a leaking UST. As soil sampling proceeds toward the northeast, the depth to impacted soils decreases. Figure 4.1 presents a soil sampling profile along geologic cross-section line C-C' and Figure 4.2 shows a map of the soils which exceed the 10  $\mu$ g/g TPH protection level; i.e., soils which lie within this isocontour for the MPA. Figure 4.1 clearly illustrates the changing depth of maximum TPH impacts towards the northeast. These data tend to indicate that the shallow TPH impacts in the north eastern area of the MPA may result from surface releases and may not be a result of subsurface releases from the former USTs. The direction of groundwater flow toward the north and northwest further supports this hypothesis. Another possible soil impacting mechanism would be residual contamination left in the soil by seasonal variations in the water table. Greater concentration of TPH would be expected closer to the water table (i.e., at greater depth in the soil column) if this were true. Clearly in the northeastern area of the MPA, this is not the case.
